DALTON LAKE DAM

STE. GENEVIEVE COUNTY, MISSOURI

PHASE 1 INSPECTION REPORT NATIONAL DAM SAFETY PROGRAM

DECEMBER 1978

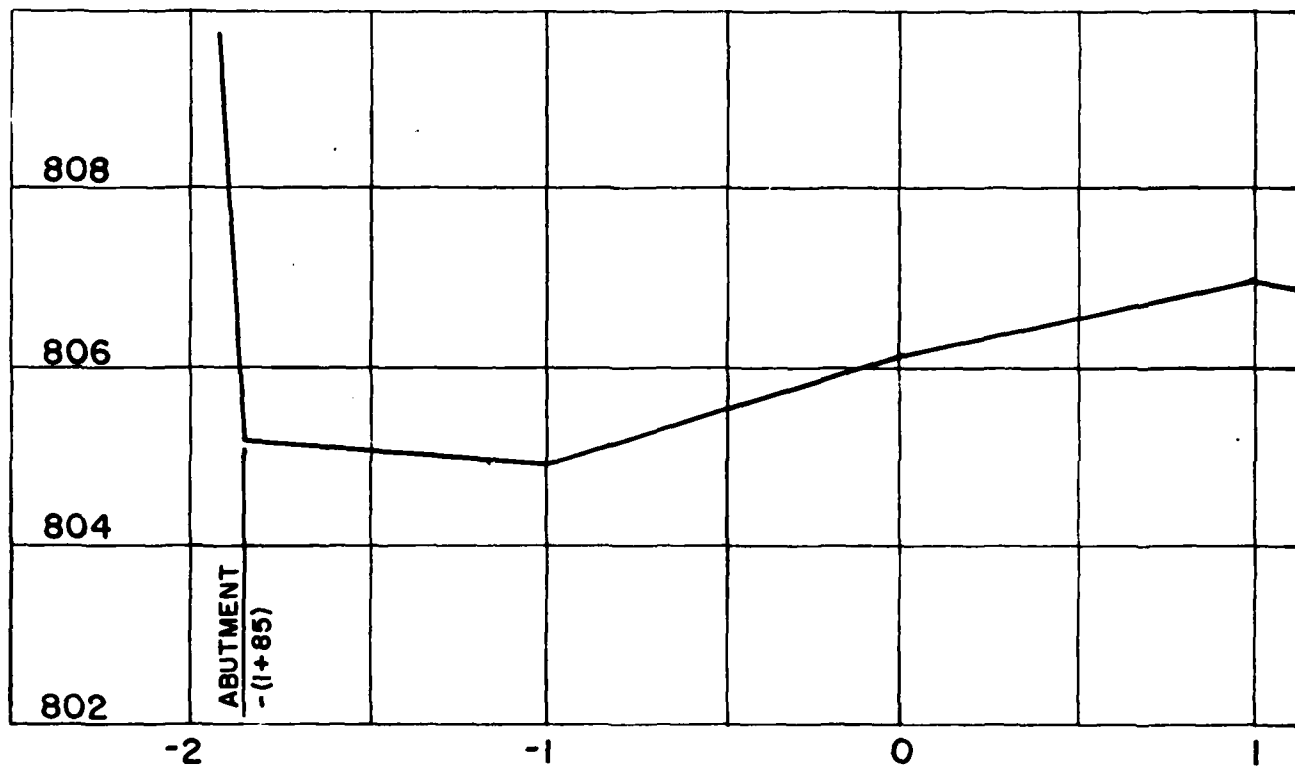
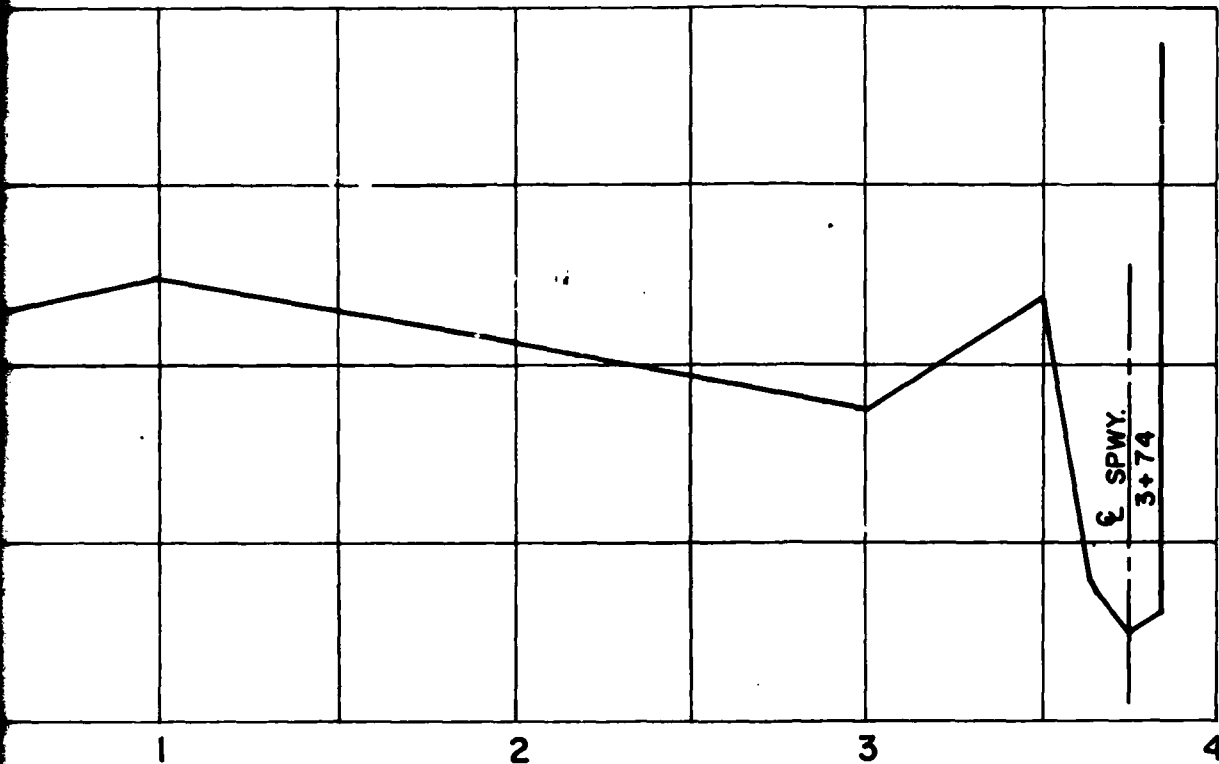
PLATE 2

The crest of the dam was found to be approximately 2 feet lower near the left abutment than in the area adjacent to the spillway. (The low point of the dam is approximately 2 feet higher than the spillway crest.) As a result, the capacity of the spillway to discharge lake outflow without overtopping the dam is reduced.

(2) It is recommended that the low area on the top of dam located near the left abutment be raised such that it will not limit the spillway capacity. Since it is possible that the low area is a result of settlement due to consolidation of the embankment and foundations soils, and since it is not known if all or nearly all of the settlement that is probable has taken place (the dam is about 4 years old), it is recommended that future settlement of the dam be monitored in order to determine overtopping potential and conditions affecting the operation of the spillway.
